Manhole Inspection Summary

Manhole # S41C__041MH

Insp Date: **6/26/08 12:25 PM**

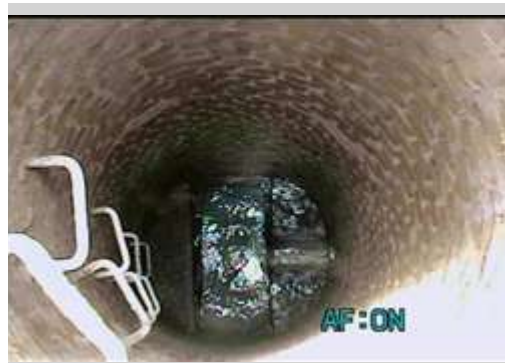
Top View

top view & steps

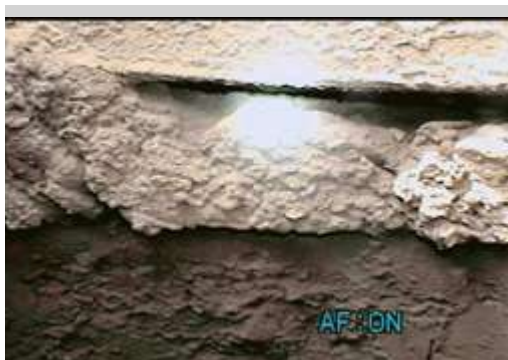
Miscellaneous

frame adj

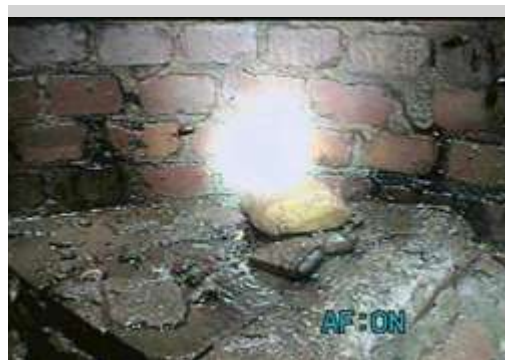
Defect 4

Infiltration: ☐ None ☐ Joint ☐ Cracks ☐ Mortar ☐ Roots ☒ **Wall**

bench debris & infiltration in barrel

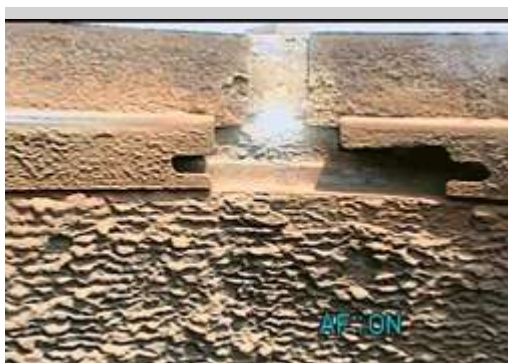
Defect 2

Condition: ☐ Sound ☒ **Cracked** ☐ Leaks

frame

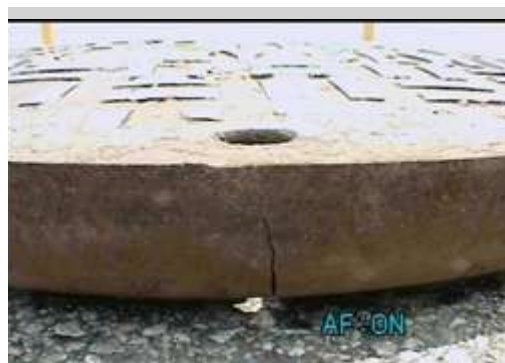
Defect 1

Comments **aaa Cover is cracked & fractured**

Condition: **Cracked**

cracked cover

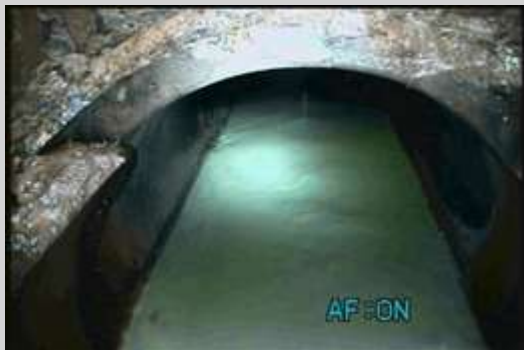
12 O'Clock Outflow

24 in. Circular Gravity Sewer
Pipe Out @ 12 O'Clock

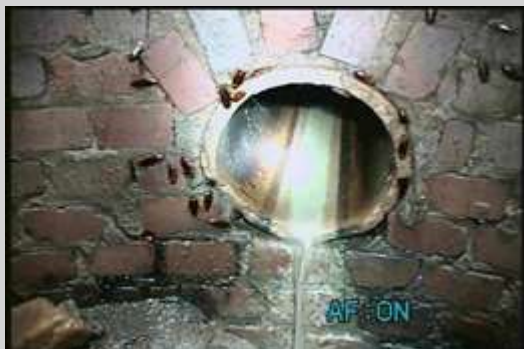
3 O'Clock Inflow

8 in. Circular Gravity Sewer
Pipe In @ 3 O'Clock

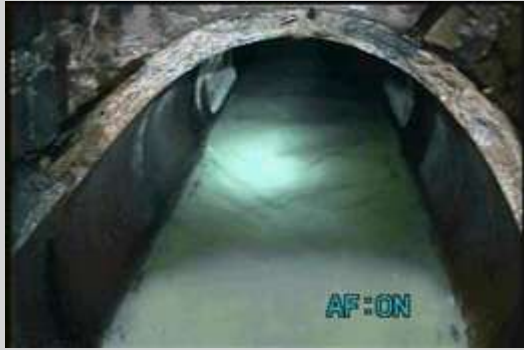
6 O'Clock Inflow

27 in. Circular Gravity Sewer

Pipe In @ 6 O'Clock
